2 Year Follow-up on Full Thickness, non-retracted Rotator Cuff Tear Treated with Stem Cells

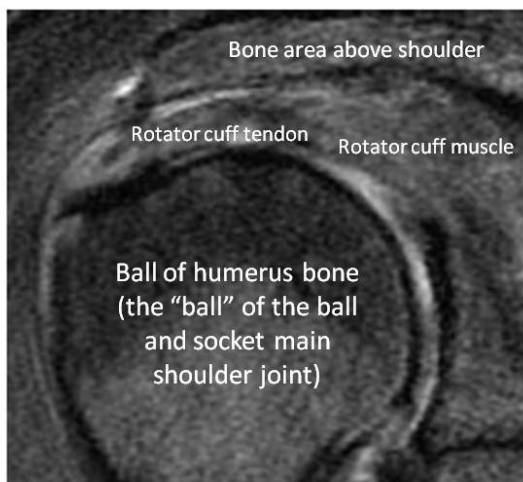
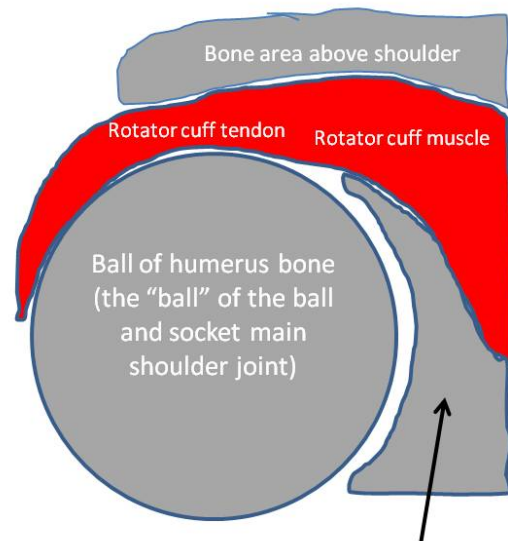
2.04.2008 COR MRI

COR MRI. ET=7, TR=2350, TE=62.2

Acetebulum or shoulder joint socket

The image above is this patient's pre-injection coronal MRI. A coronal MRI slice is one that lets you look from the front or the back. Here you can see the MRI on the left and the diagram of the MRI to the right. The rotator cuff tendon is the area of interest. The rotator cuff like any muscle has two parts, the muscle belly and the part that attaches the muscle to the bone, the muscle tendon. Rotator cuff tears commonly occur at the muscle tendon area. In addition, MRI images

come in many different flavors, some show water as bright or a lighter color, which is what's being shown here in these PDFS sequences. So on this image, a darker appearing tendon is good, one with light spots in it is bad. A normal rotator cuff tendon in this type of MRI sequence would be a uniform darker color or black (depending on age).

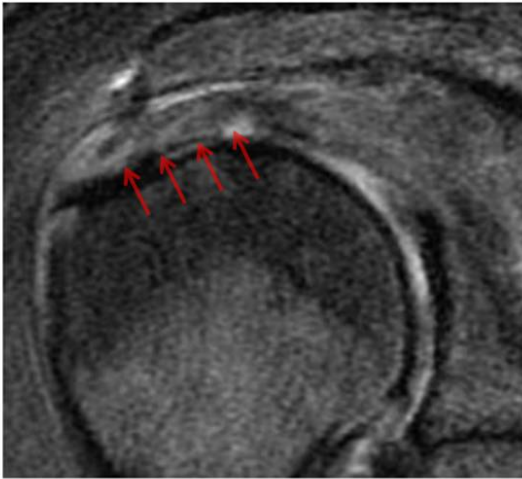
2.04.2008 COR MRI

COR MRI. ET=7, TR=2350, TE=62.2

Now for the patient MRI's. Above on the left is an MRI taken 2 months before her stem cell injection in April 2008, the image on the right is her 2 year follow-up MRI. The left MRI shows the rotator cuff tendon (red arrows) which is bright in color and mottled in appearance. This means that it's a full thickness rotator cuff tendon tear with severe degeneration (she's 78 years old at the time of this picture). To the right is her two year follow-up MRI showing a darker appearing rotator cuff tendon (yellow arrows) without any light color that goes all the way through the tendon (she's 80 years old in this picture). Clearly an improvement that's still holding and demonstrated not only by her reports of no pain and full function, but also objective MRI imaging two years later.

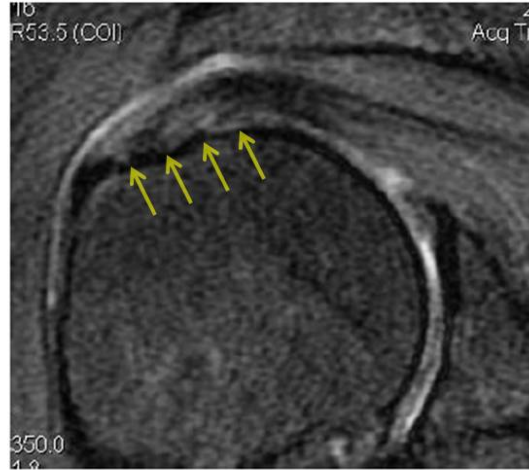
6.24.2010 COR MRI

COR MRI. ET=7, TR=2350, TE= 62
